USAAVLABS TECHNICAL REPORT 66-55

DIAGNOSTIC NOISE STUDY OF POWER TRANSMISSION SYSTEMS

Final Report

CONTRACT DA 44-177-AMC-249(T)
CURTISS-WRIGHT CORPORATION
CALDWELL, NEW JERSEY

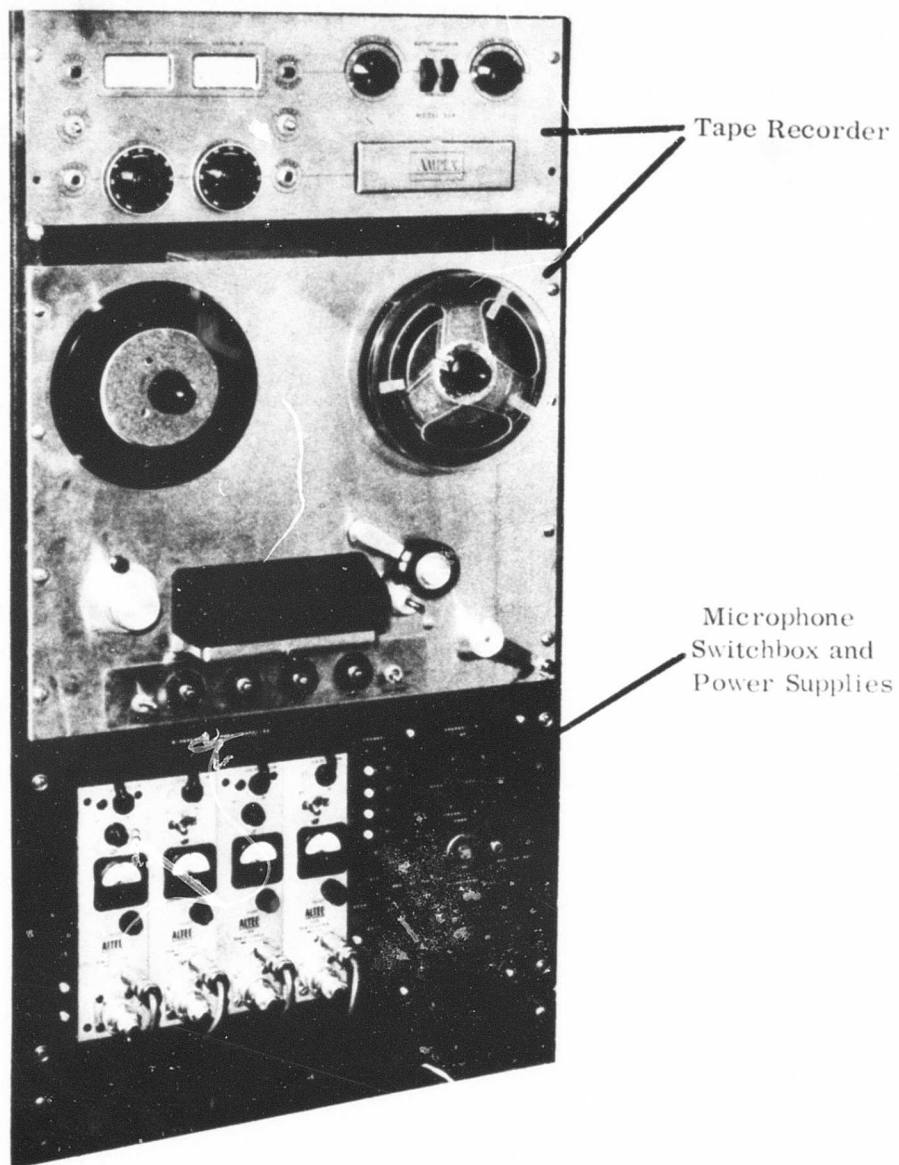
Figure 1. Diagnostic Sonic Recording Equipment.

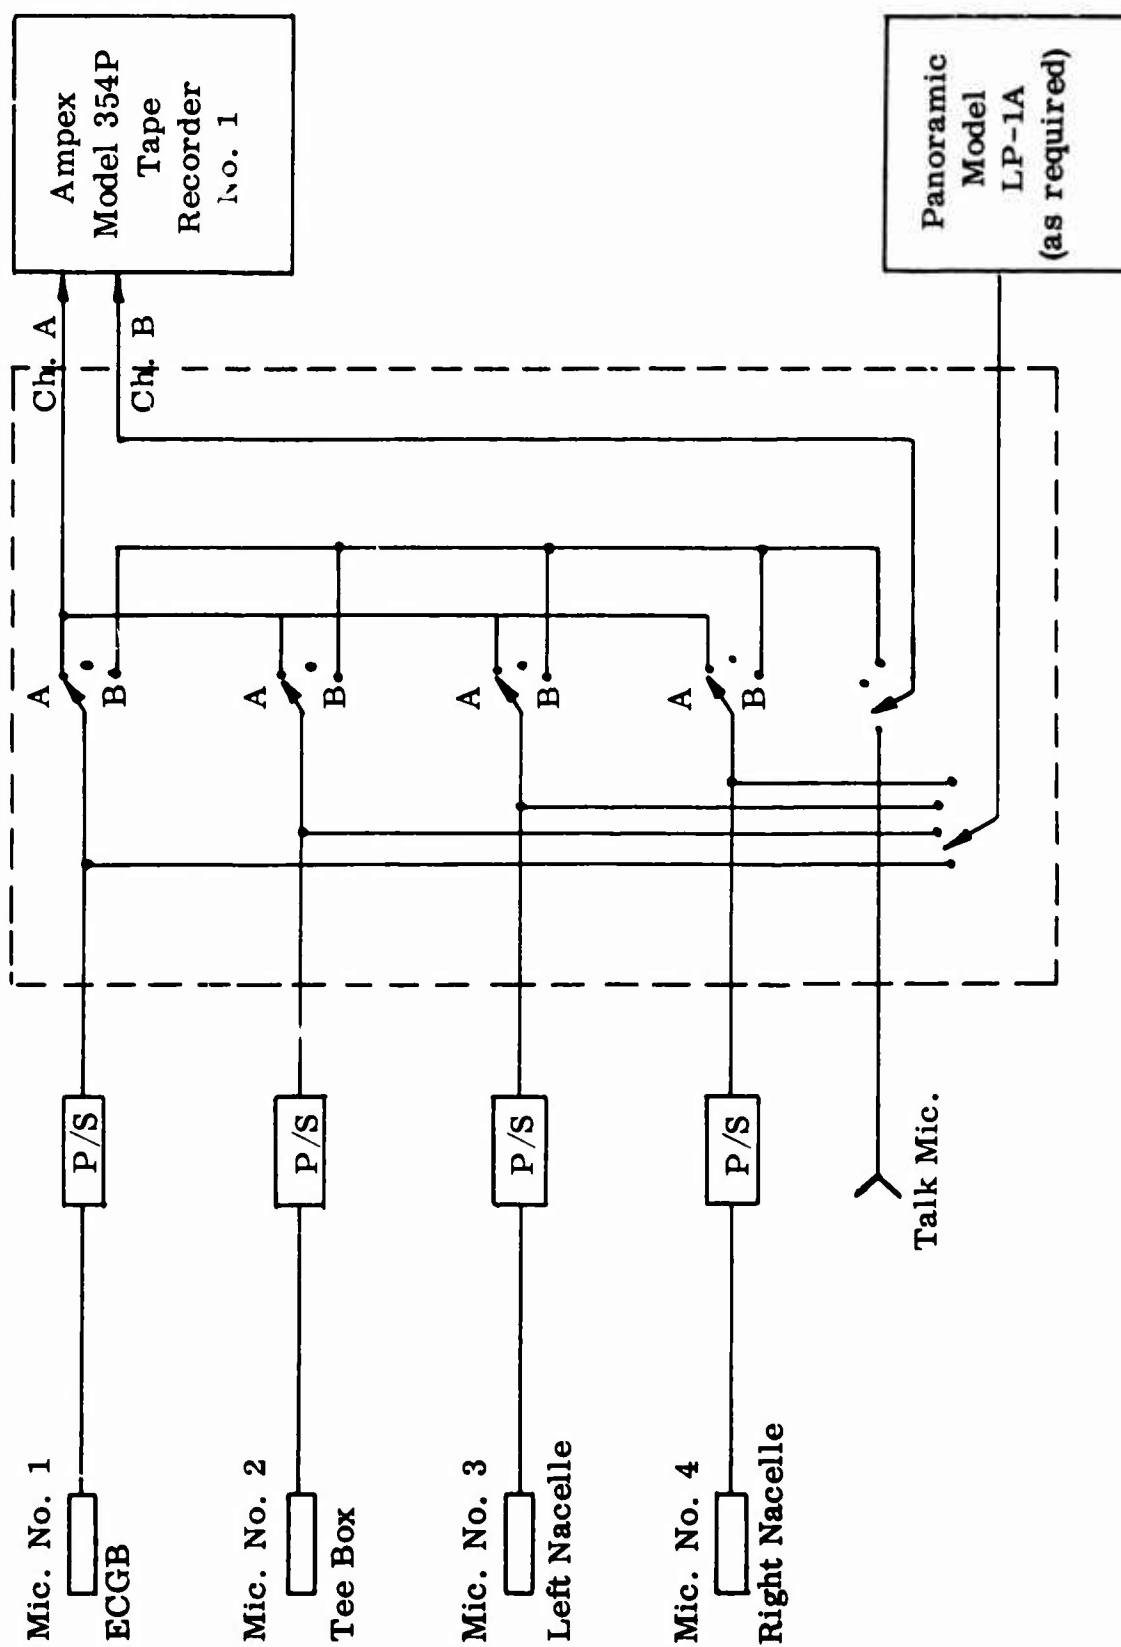
Figure 2. Block Diagram - Data Acquisition System.

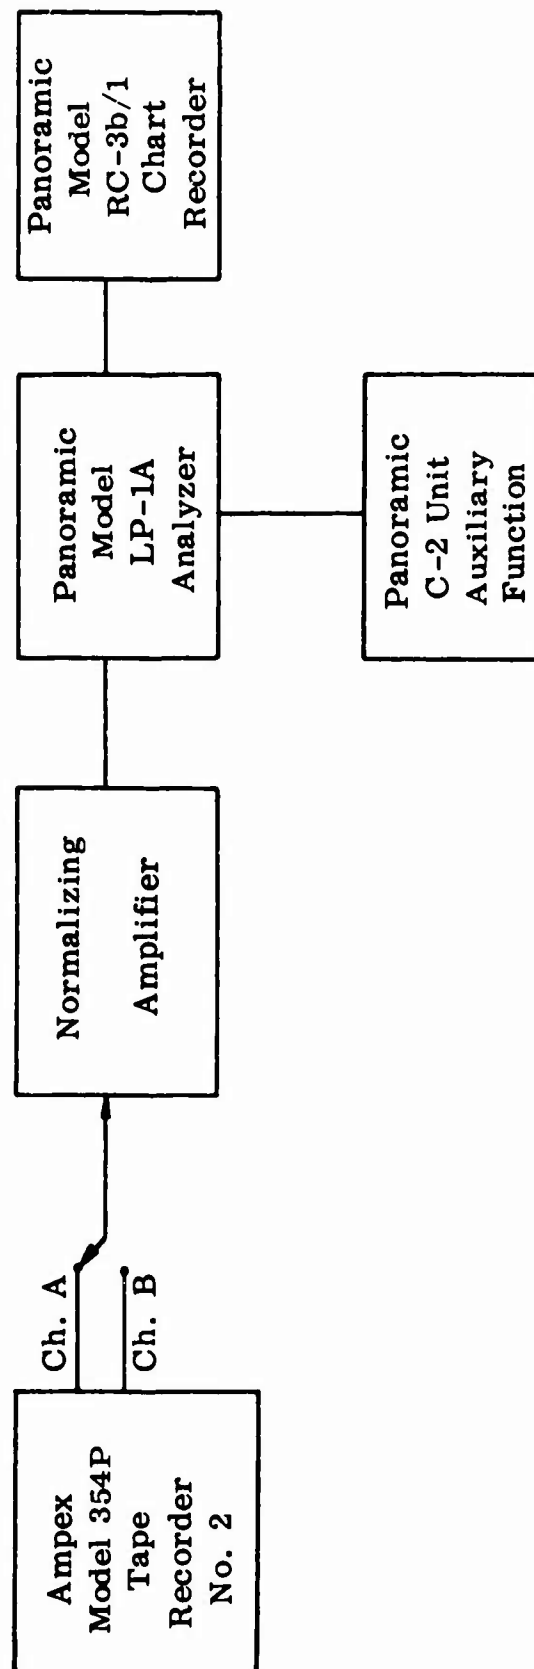
Figure 3. Block Diagram - Data Reduction System.

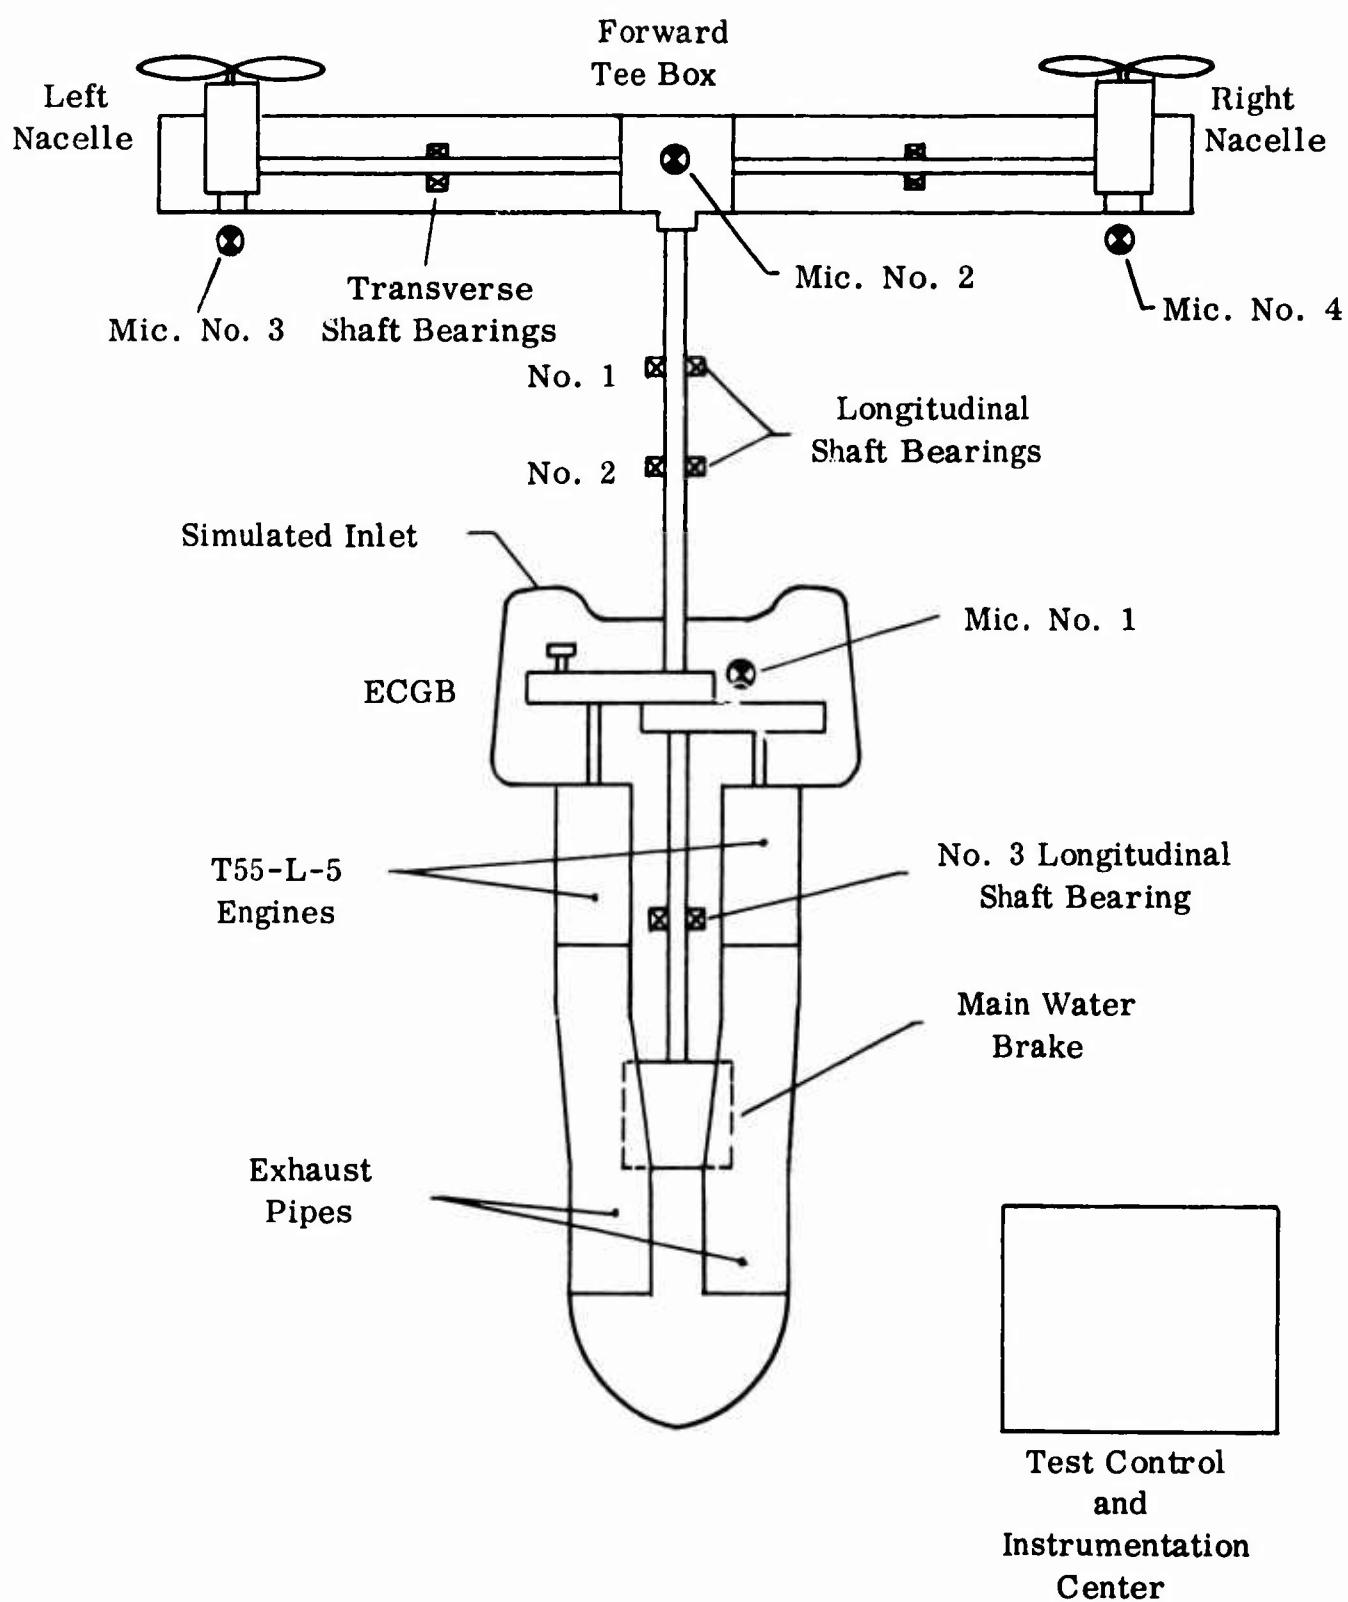
Figure 4. Schematic X-19 Half-System Test Rig.

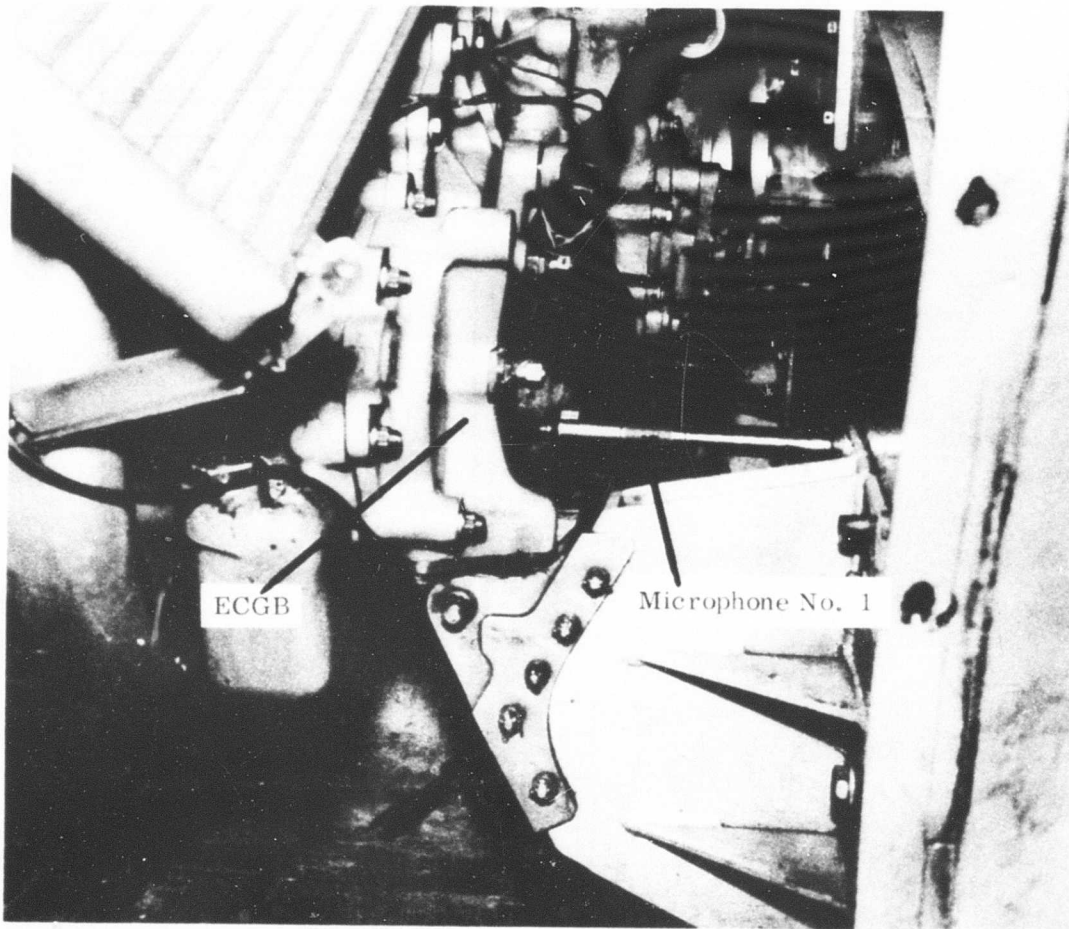
(Right-Side View)

Figure 5. Microphone No. 1 Location at ECGB.

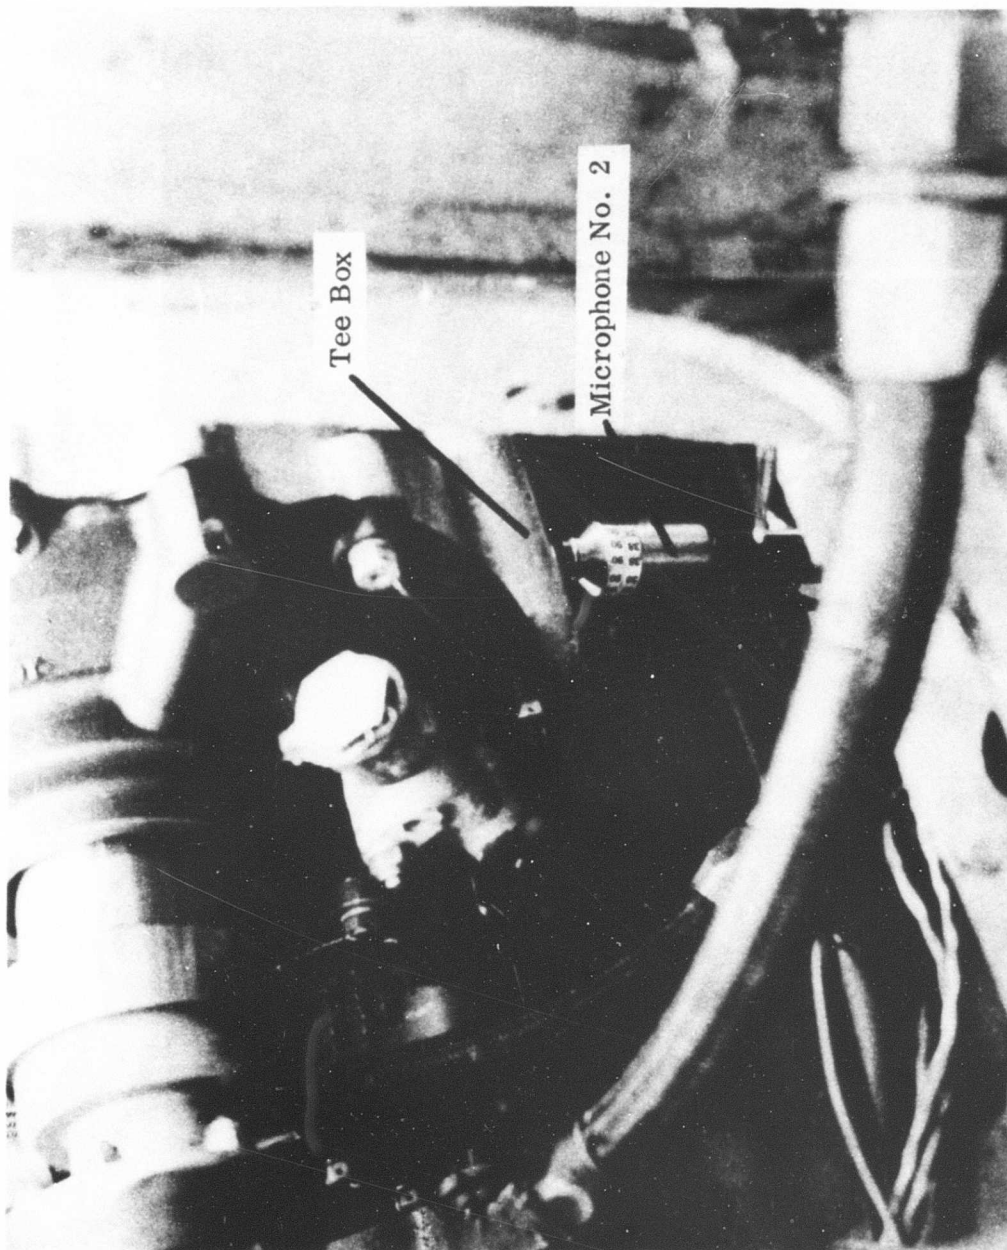
Figure 6. Microphone No. 2 Location at Tee Box

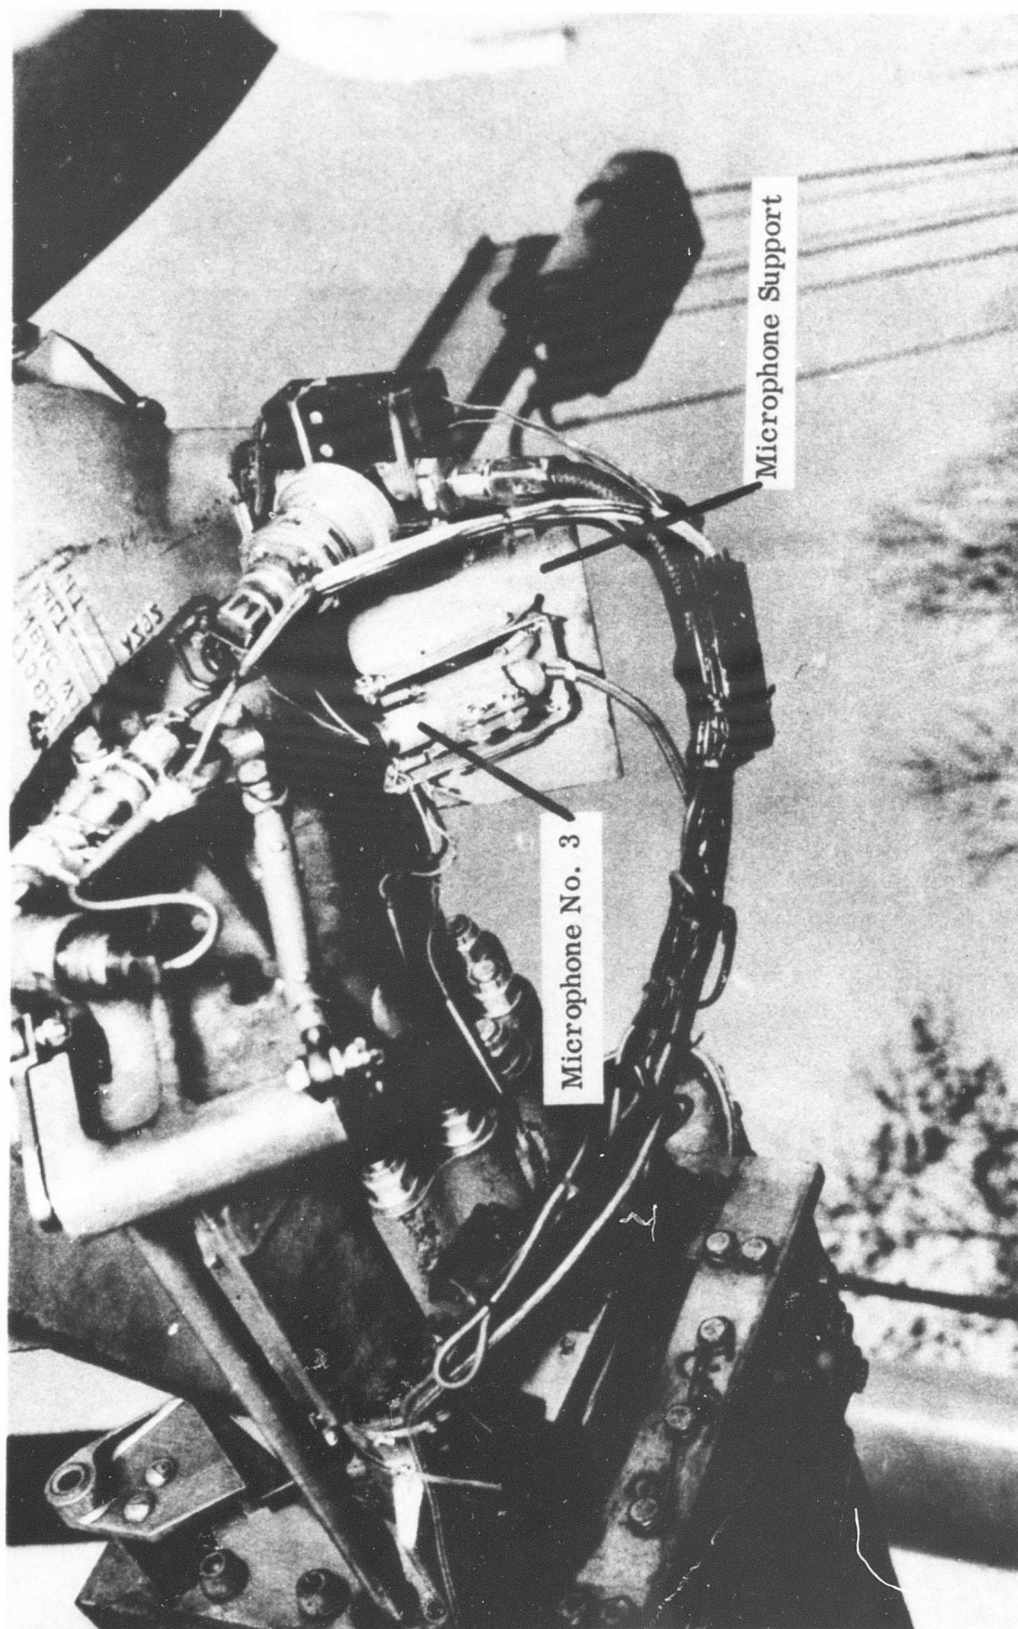
(Viewing Bottom of Left Nacelle)

Figure 7. Microphone No. 3 Location at Left Nacelle

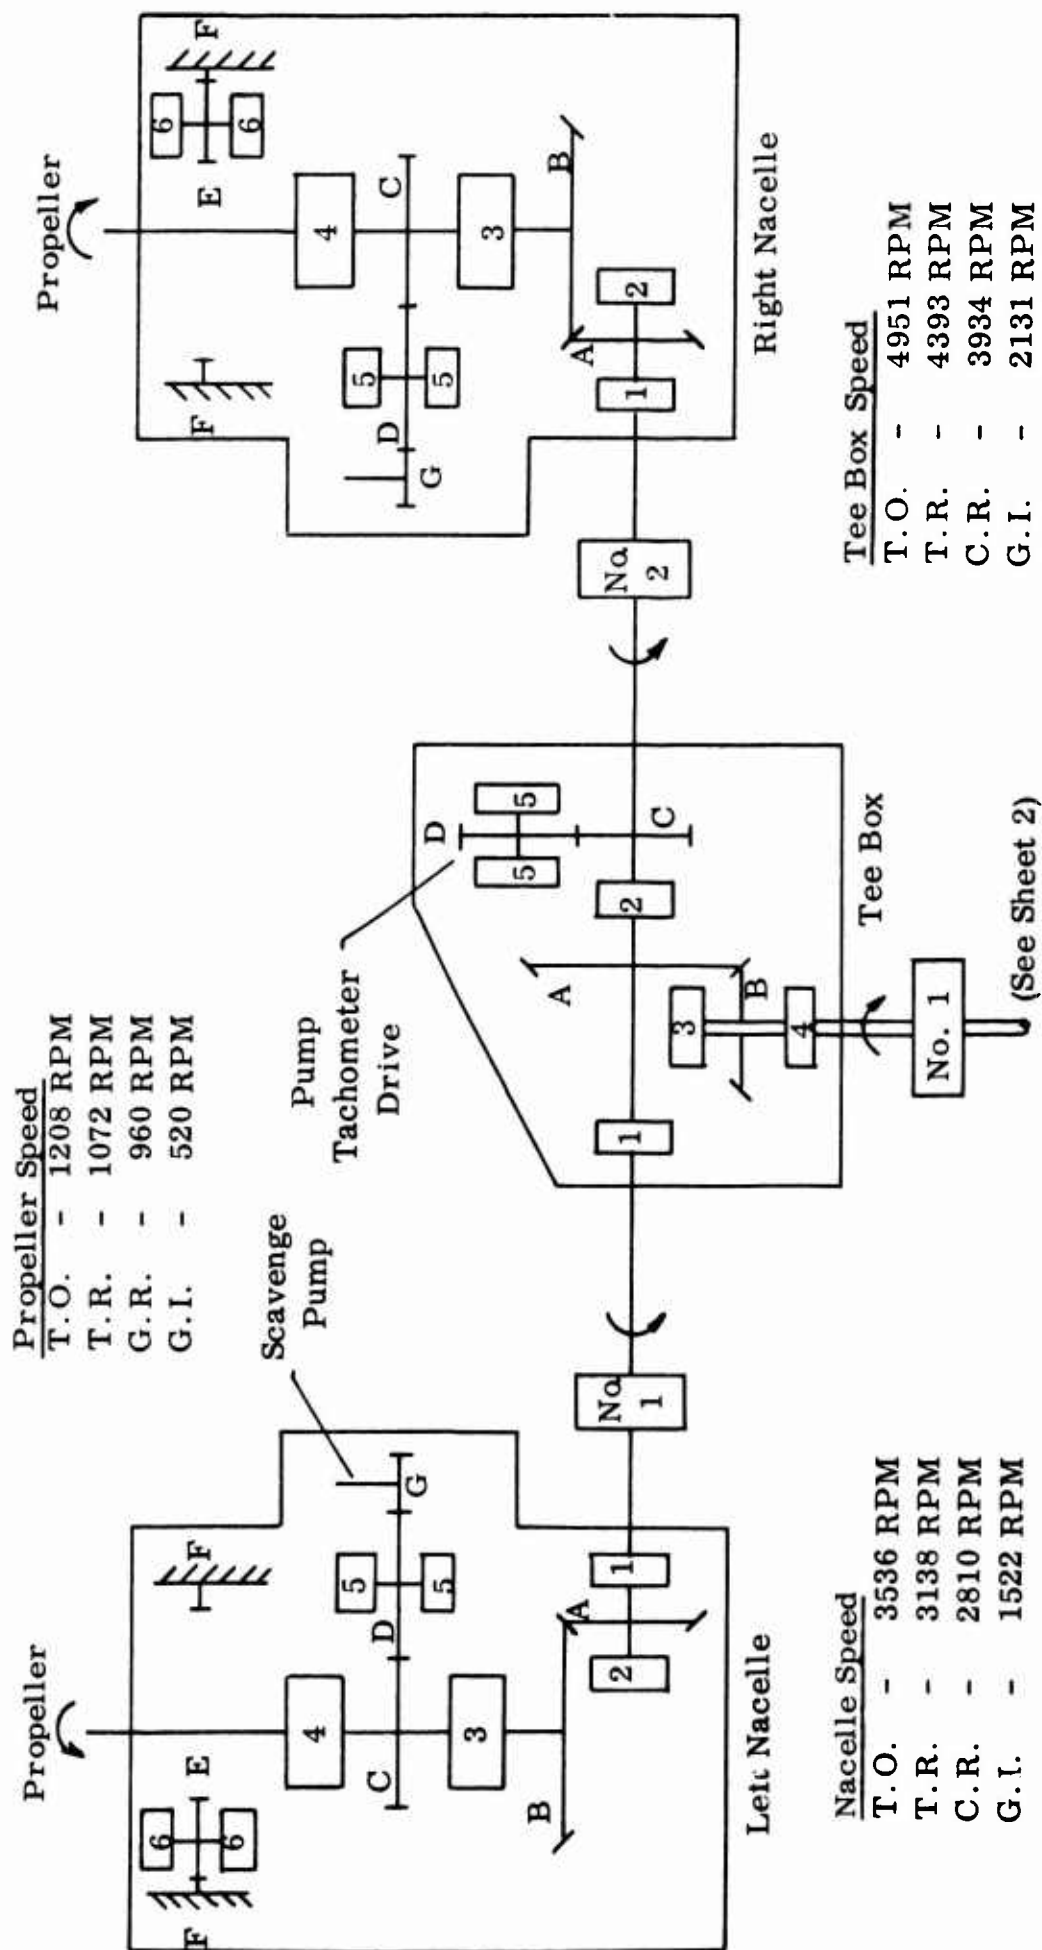
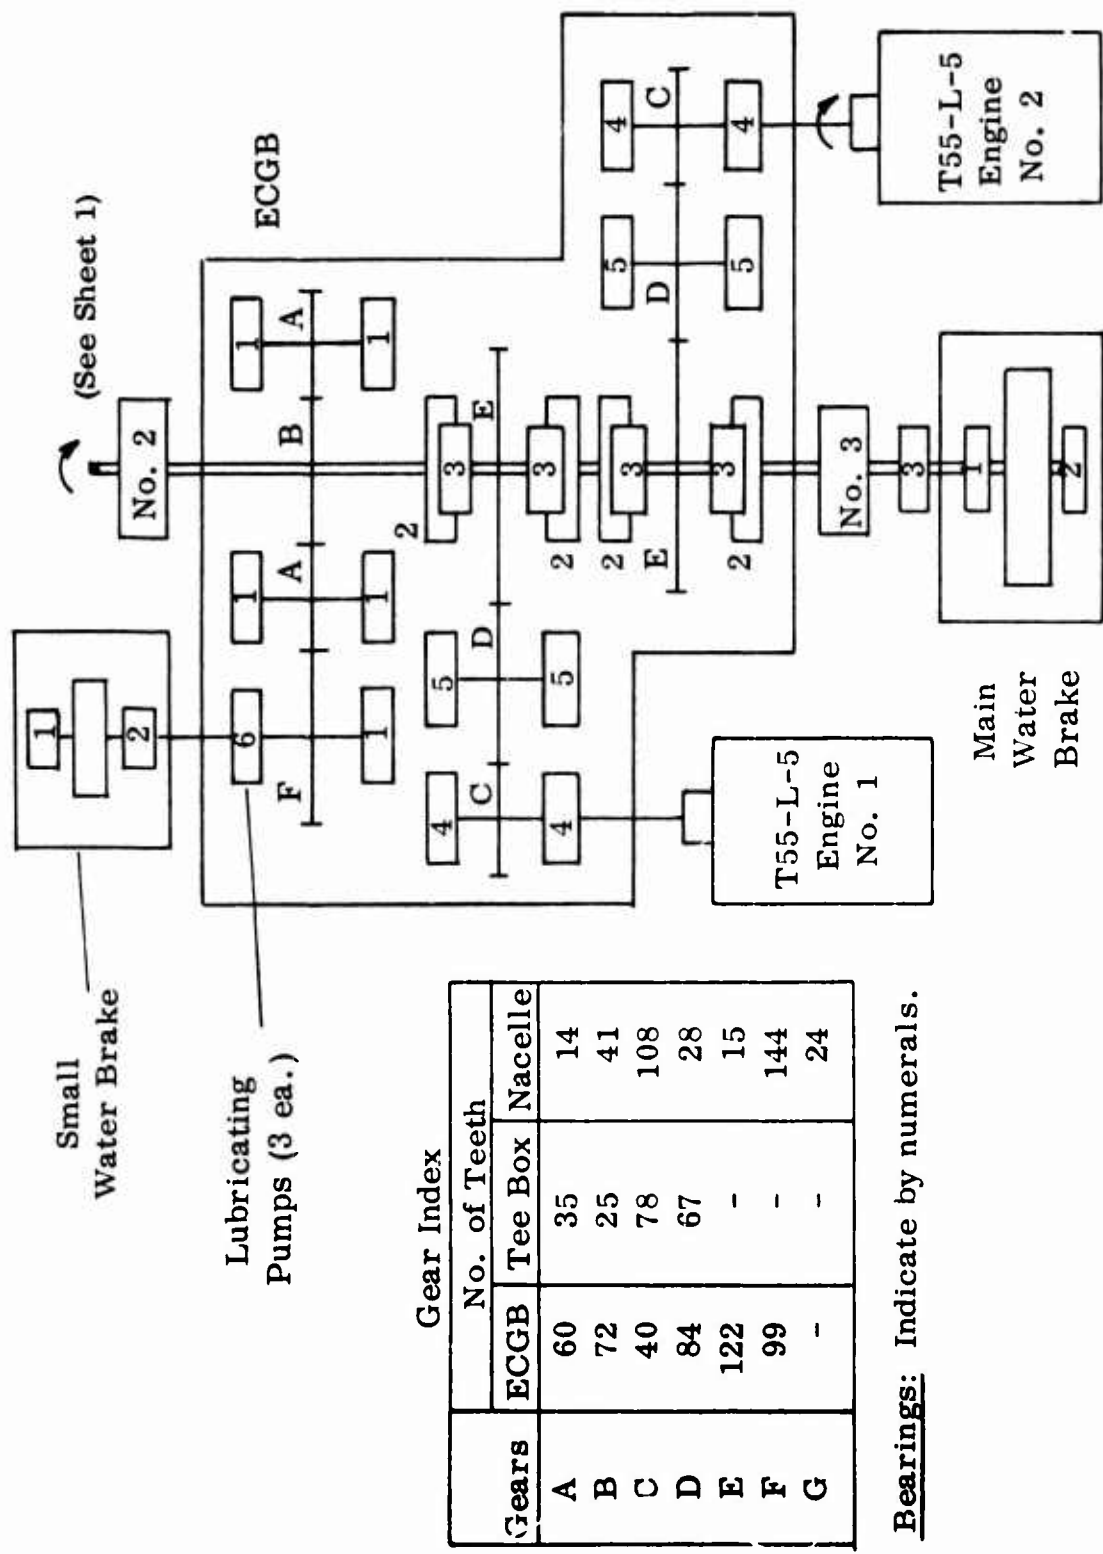
Figure 8. X-19 Half-System Drive Schematic.
(Sheet 1 of 2)

Gears	Gear Index		
	ECGB	Tee Box	Nacelle
A	60	35	14
B	72	25	41
C	40	78	108
D	84	67	28
E	122	-	15
F	99	-	144
G	-	-	24

- T.O. - 15100 N₂RPM
- T.R. - 13400 N₂RPM
- C.R. - 12000 N₂RPM
- G.I. - 6500 N₂RPM

Figure 8. X-19 Half-System Drive Schematic.
(Sheet 2 of 2)

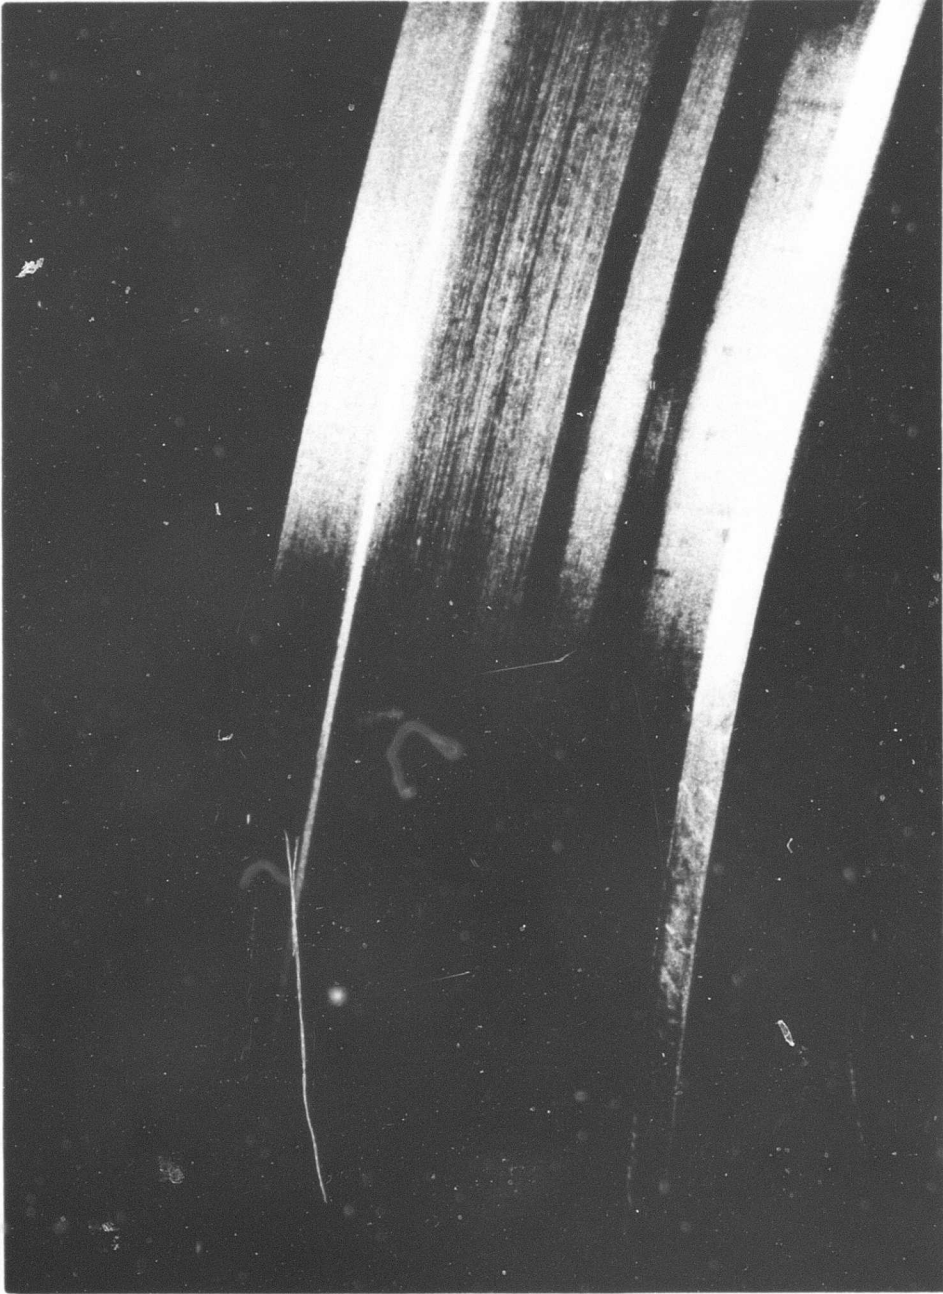
Inspection of the ECGB at a total rig time of 348:28 hours revealed that the forward No. 4 pinion gear bearing from the No. 2 box had failed. This failure consisted of a grooved outer raceway and slightly grooved and spalled rollers. Photographs of these irregularities are shown in Figures 9 and 10. This bearing failure was detected acoustically during an analysis of a tape recording made at a total rig time of 347:40 hours (see Section IV-C).

Figure 9. ECGB No. 4 Pinion Gear Bearing - Outer Raceway

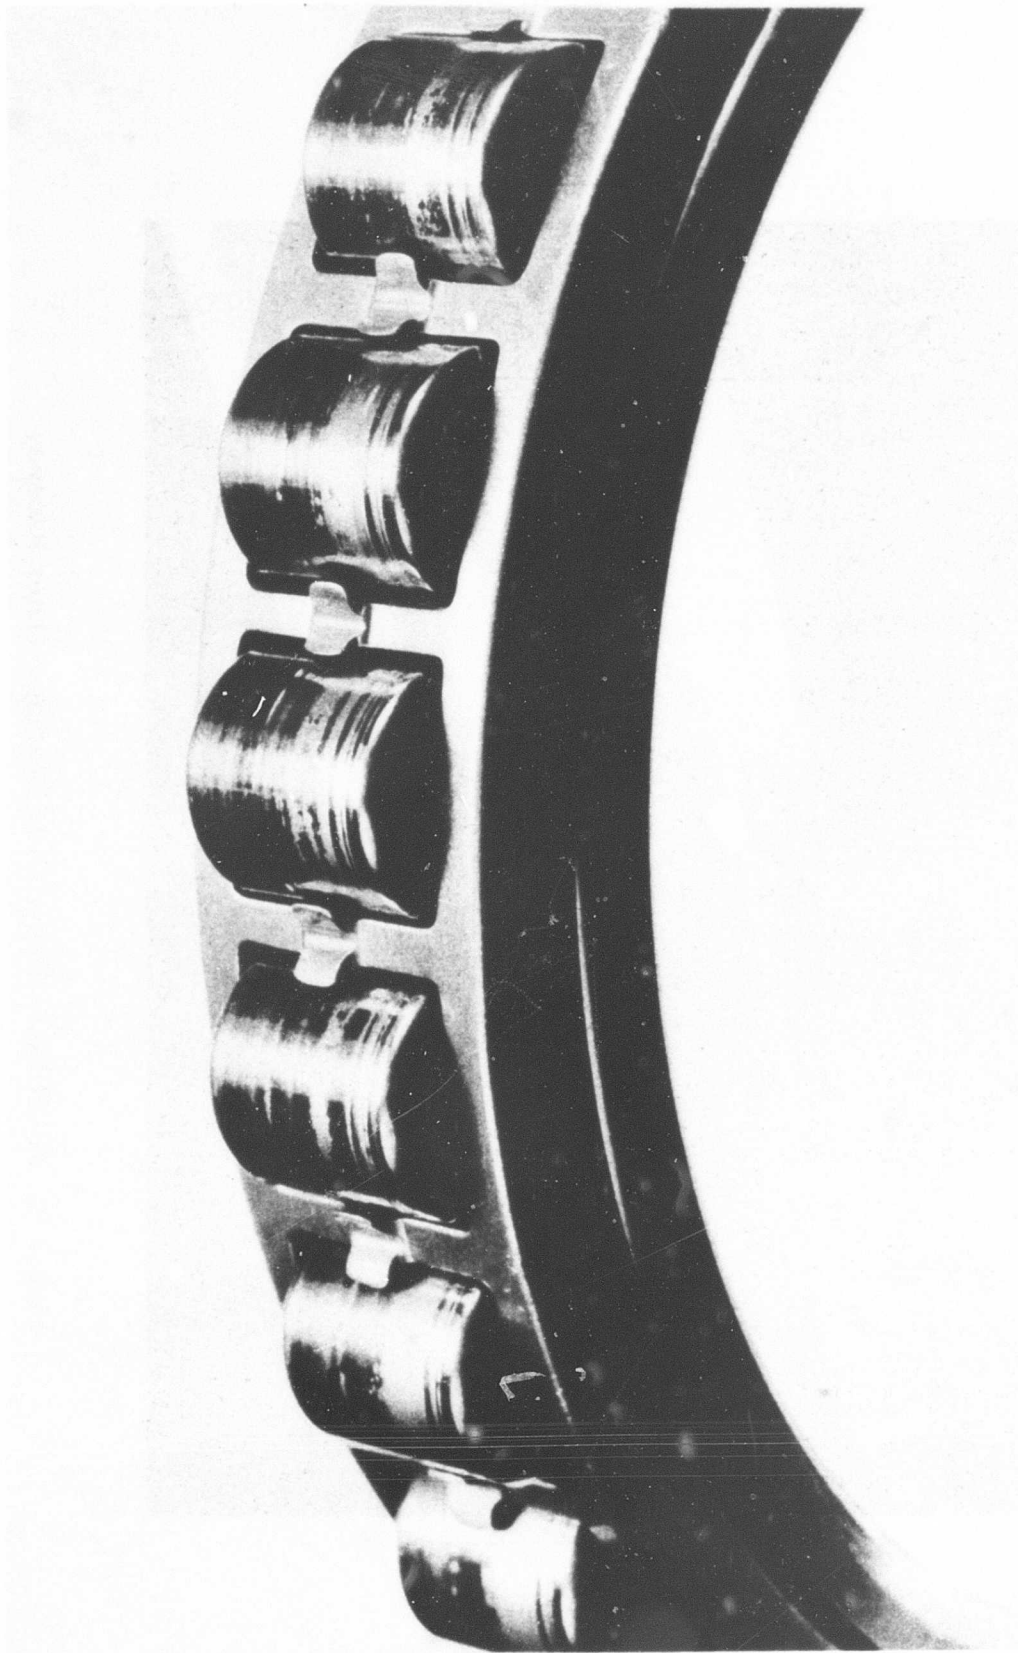
Figure 10. ECGB No. 4 Pinion Gear Bearing - Rollers

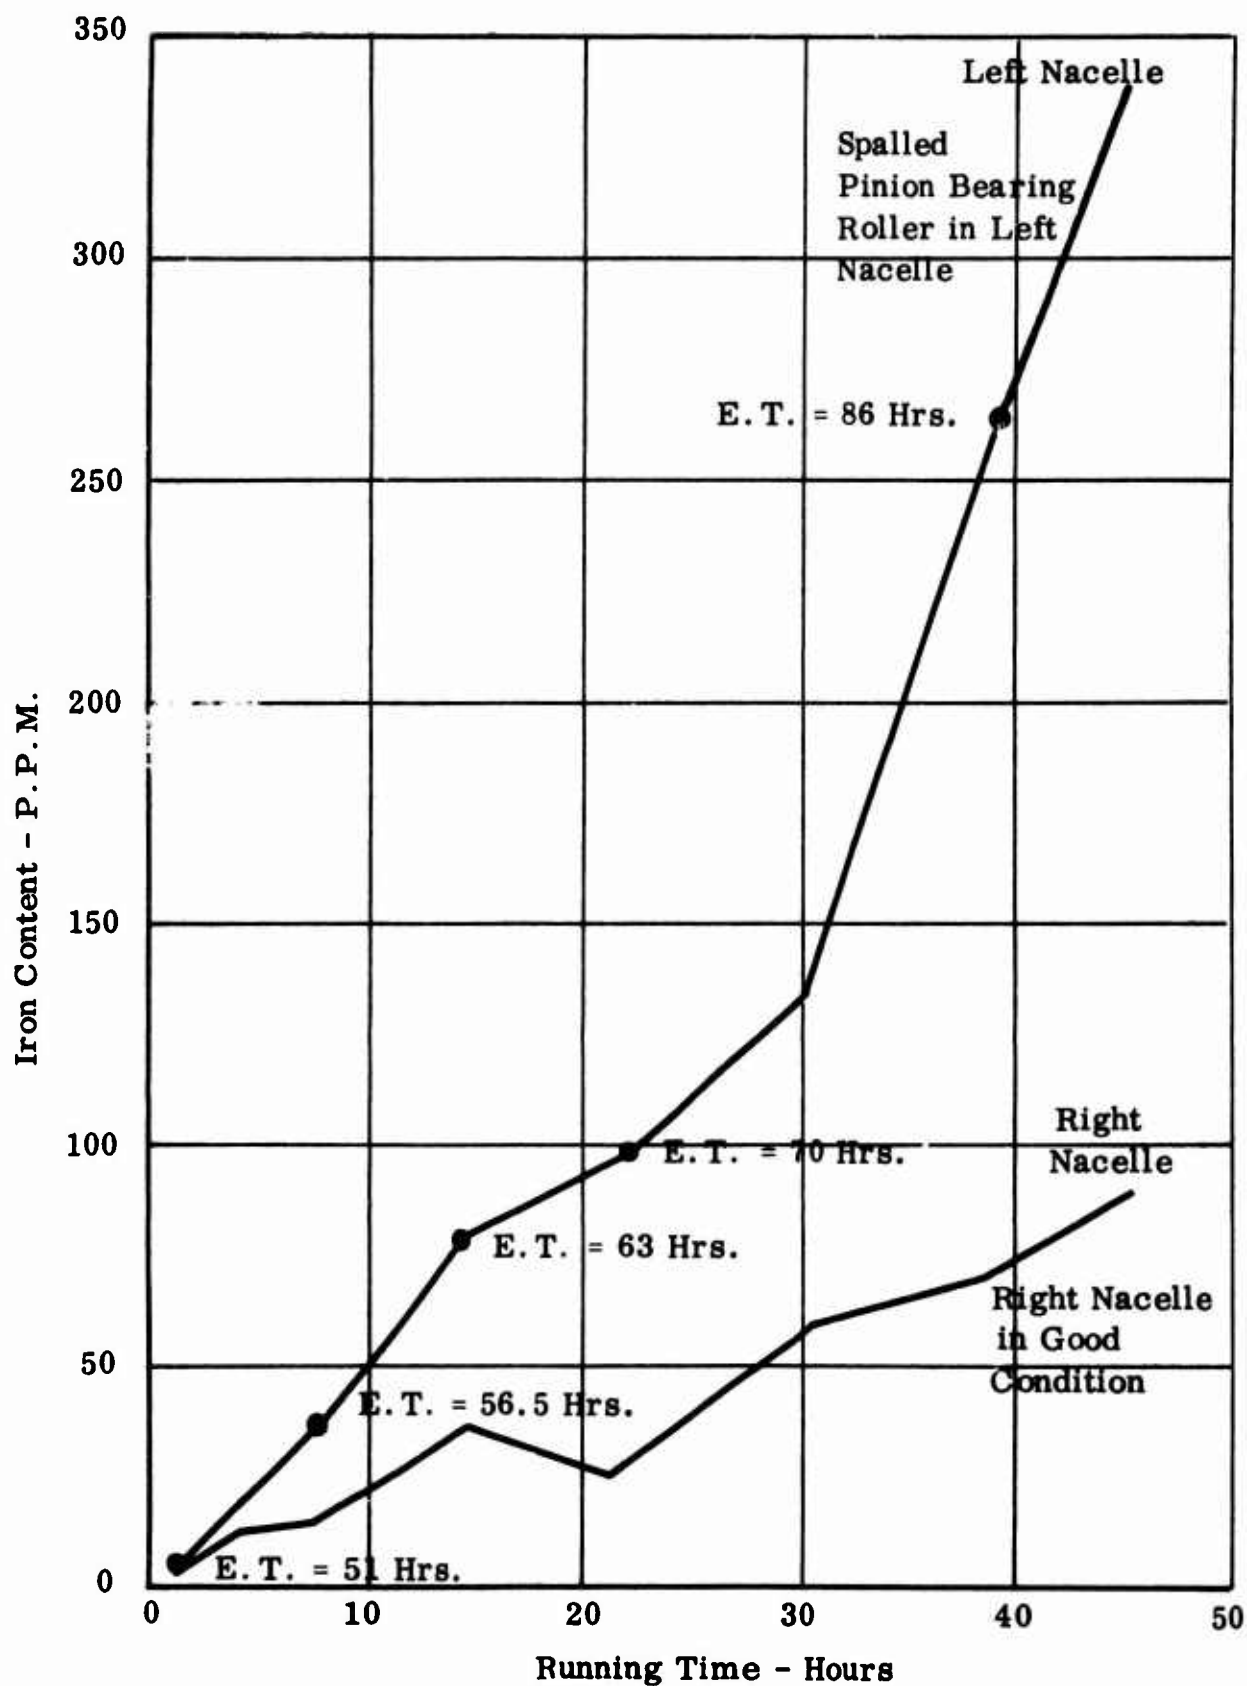
Perhaps the best correlation between mechanical condition and spectrometric oil analysis was achieved due to spalling of the left nacelle No. 1 bearing, as shown in Figure 11. It is evident that this spalling started within the first 5 hours of testing and grew progressively worse. Correlation with acoustic data is also evident, as explained under Sections IV-C and -D.

Figure 11 is a plot of iron content vs. running hours for both nacelles. It is obvious from this plot that spalling of the left nacelle started within the first 5 hours. The points superimposed on this left nacelle curve represent the endurance hours noted on the acoustic spectrograms shown in Figure 27. Comparison of Figures 11 and 27 shows a definite correlation of acoustic data and spectrometric oil analysis beginning with

63 hours of endurance. At both 63 and 86 hours of endurance (Figure 27), the amplitude of the nacelle gear and bearing frequency has increased progressively along with an increased iron content, as shown in Figure 11. A visual inspection revealed a spalled roller on the left nacelle No. 1 bearing and marked bevel gears. A photograph of this spalled bearing is shown in Figure 29. No scuffing or pitting was evident. Unfortunately, no recordings were taken at "idle" RPM after 86 hours of endurance due to the cessation of testing because of contract termination. Consequently, at the maximum iron content shown in Figure 11 at 91:45 hours of endurance, there is no corresponding acoustic spectrogram.

Figure 11. Spectrometric Oil Analysis of Propeller Nacelle Assemblies - X-19 Transmission System.
